**Flood Control Project Maintenance
Levee Inspections**
LMA District Cover Sheet
Spring 2018 Levee Inspection Results

Reclamation District No. 0010 Honcut

Spring 2018 Levee Inspection Results

Waterway			Bank	Unit Miles
Unit No. 01 Simmerly Slough			Right	7.65
	Spring (March - May)	Summer (June - August)	(September - November) Fall	Winter (December - February)
Unit Maintenance Rating (Fall Only)				
Date of Inspection	4/10/2018 - 4/10/2018			
DWR Inspector	Sterling York			
Accompanied By	Finlay Williams

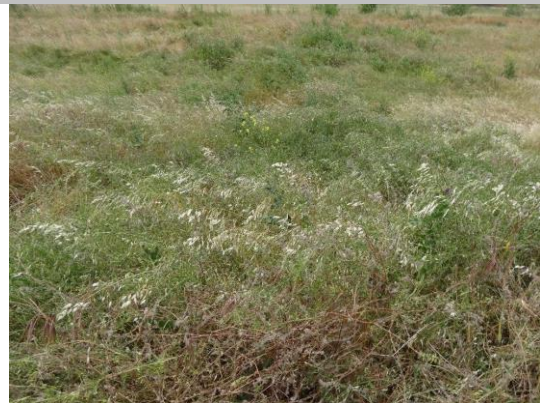
Photo 1 of 3 : UCIP_SP_2018_24768_44450.jpg

Comment Code						
Inspector Comment						
FS_ID:24768 DS_ID:21298 EP_NO: N/A Repair Type: Non-Urgent Crossing Status: Found UCIP Comments: Crossing is buried--found indicators of concrete headwall. Need to contact owner to determine status of crossing. This crossing is referenced in the USACE Periodic Inspection as item USACE_CESPK_HON2_2013_p_0378. FIELD_STRUCT_DESC: 24-inch corrugated metal gravity drainage pipe through the levee, 13 feet below the crown. Corrugated metal cutoff wall around the pipe at each shoulder. Flap gate on the waterside (WS) end. Slide gate on the landside (LS) end. Concrete headwall at each end. Metal marker on the WS slope. [Additional Reference(s): DWR Levee Log, 2005. USACE Sacramento O&M Manual 151, May 1953, (Station 576+75)]. FS Date: 4/30/2013

View of waterward slope.

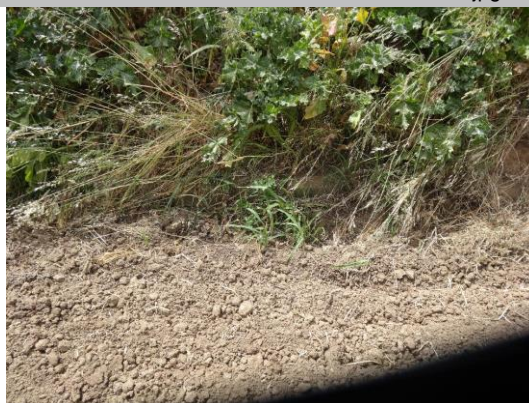
Photo 3 of 3 : UCIP_SP_2018_24768_44449.jpg

View of concrete headwall visible through dense vegetation.

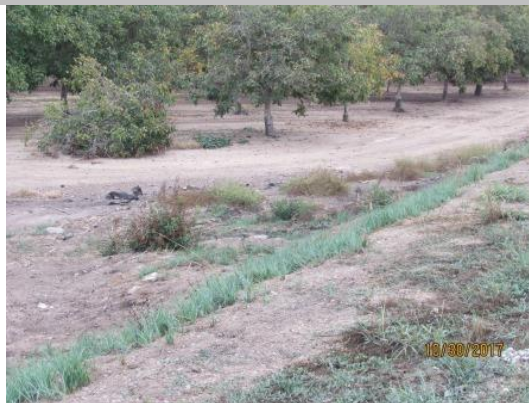
Photo 1 of 1 : SP_2018_RD0010_164_69_20180302_00034.jpg

LM Start	9.26	Rating **	A/W	Issue No.	69
LM End	9.26	Issue Type +	En	Location *	LS
Category	Earthen Levee			GPS Latitude/Longitude	
				Start	End
Item	Encroachments			39.285845 °	39.285845 °
				-121.600362 °	-121.600362 °
DWR ID	DWR_RD0010_02_s_2016_69				
Comment Code					
PR : Prunings					
Inspector Comment					
Remove pruning's from levee toe.

View looking downstream landside where pruning's have been removed, Fall 2017.

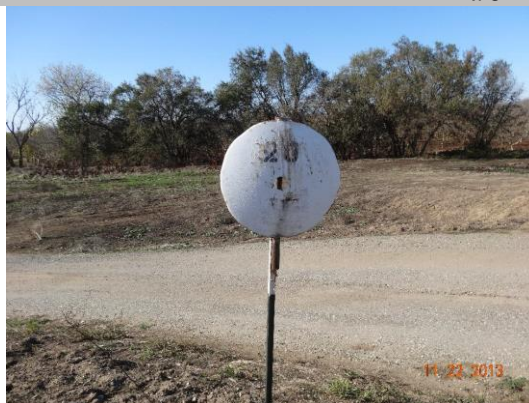
Photo 1 of 3 : UCIP_SP_2018_24769_44454.jpg

Comment Code					
Inspector Comment					
FS_ID:24769 DS_ID:21299 EP_NO: N/A Repair Type: Non-Urgent Crossing Status: Found UCIP Comments: Need to contact owner. Need to clear debris from concrete distribution box on waterward and remove debris blocking landward side.This crossing is referenced in the USACE Periodic Inspection as item USACE_CESPK_HON2_2013_p_0383. FIELD_STRUCT_DESC: 24-inch corrugated metal gravity drainage pipe through the levee, 12 feet below the crown. Corrugated metal cutoff wall around the pipe at each shoulder. Flap gate on the waterside (WS) end. Slide gate on the landside (LS). Concrete headwall, saddle, and apron on the WS end. Metal marker on the WS shoulder. [Additional Reference(s): DWR Levee Log, 2005. USACE Sacramento O&M Manual 151, May 1953, (Station 582+72)]. FS Date: 4/30/2013

Marker visible on waterward side shoulder, crossing is referenced as No. 20.

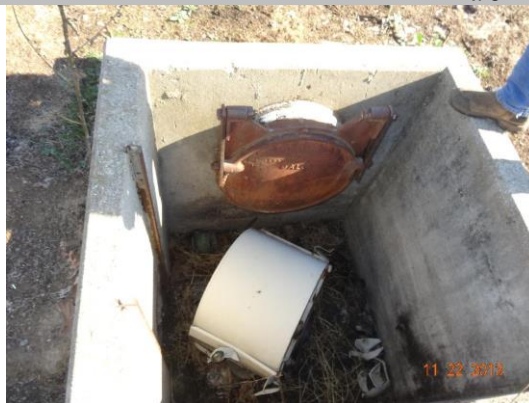
Photo 2 of 3 : UCIP_SP_2018_24769_44453.jpg

View of flap gate located inside concrete distribution box. Debris scattered inside box.

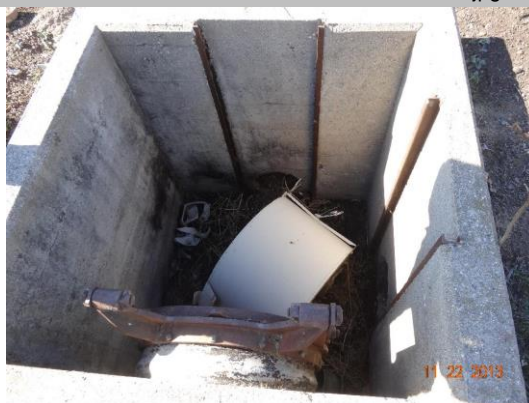
Photo 3 of 3 : UCIP_SP_2018_24769_44452.jpg

View of concrete distribution box located on waterward side.

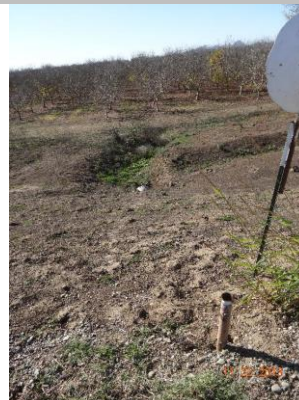
Photo 2 of 3 : UCIP_SP_2018_24835_44720.jpg

View of waterward side.

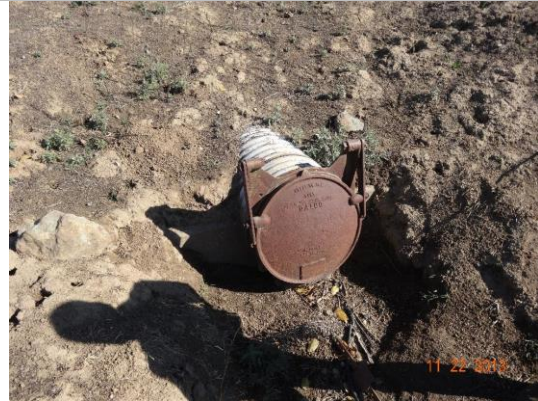
Photo 3 of 3 : UCIP_SP_2018_24835_44725.jpg

View of flap gate located on waterward side.

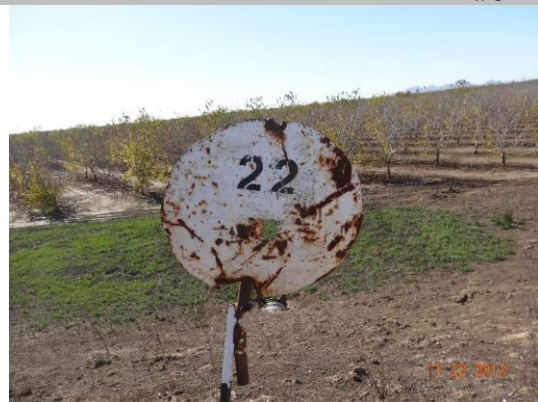
Photo 1 of 3 : UCIP_SP_2018_27776_51478.jpg

LM Start	9.71	Rating **	M	Issue No.	98	
LM End	9.71	Issue Type +	En	Location *		
Category	Supplemental			GPS Latitude/Longitude		
				Start	End	
Item	DWR UCIP Field Study			39.291474 °	39.291474 °	
				-121.603677 °	-121.603677 °	
DWR ID						
Comment Code						
Inspector Comment						
FS_ID:27776						
DS_ID:21301						
EP_NO: N/A						
Repair Type: Non-Urgent						
Crossing Status: Found						
UCIP Comments: Recommend removing debris blocking slide gate on landward side. This crossing is referenced in the USACE Periodic Inspection as item USACE_CESPK_HON2_2013_p_0402.						
FIELD_STRUCT_DESC: 24-inch gravity drainage pipe of an unknown material through the levee, 13 feet below the crown. Flap gate on the waterside (WS) end. Slide gate on the landside (LS) end. Concrete headwall at the LS toe. [Additional Reference(s): DWR Levee Log, 2005].						
FS Date: 4/30/2013

Marker visible on waterward shoulder, crossing referenced as No. 22.

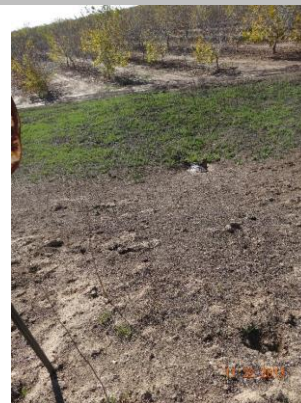
Photo 2 of 3 : UCIP_SP_2018_27776_51482.jpg

LM Start	9.71	Rating **	M	Issue No.	98 (cont)	
LM End	9.71	Issue Type +	En	Location *		
Category	Supplemental			GPS Latitude/Longitude		
				Start		End
Item	DWR UCIP Field Study			39.291474 °	39.291474 °	
				-121.603677 °	-121.603677 °	
DWR ID						
Comment Code						
Inspector Comment						
FS_ID:27776						
DS_ID:21301						
EP_NO: N/A						
Repair Type: Non-Urgent						
Crossing Status: Found						
UCIP Comments: Recommend removing debris blocking slide gate on landward side. This crossing is referenced in the USACE Periodic Inspection as item USACE_CESPK_HON2_2013_p_0402.						
FIELD_STRUCT_DESC: 24-inch gravity drainage pipe of an unknown material through the levee, 13 feet below the crown. Flap gate on the waterside (WS) end. Slide gate on the landside (LS) end. Concrete headwall at the LS toe. [Additional Reference(s): DWR Levee Log, 2005].						
FS Date: 4/30/2013

View of waterward side.

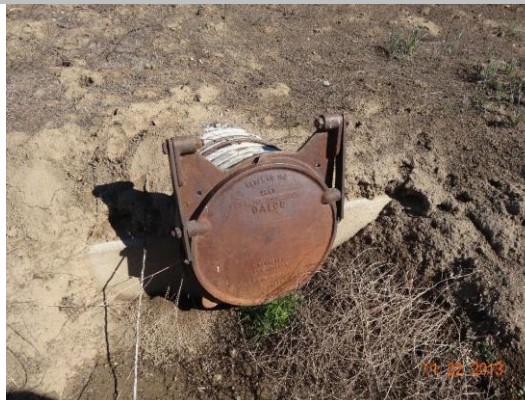
Photo 3 of 3 : UCIP_SP_2018_27776_51481.jpg

View of flap gate located on waterward toe.

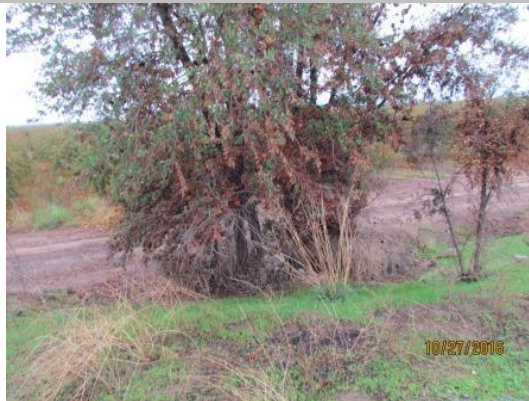
Photo 1 of 1 : SP_2018_RD0010_164_70_20180302_00035.jpg

LM Start	9.94	Rating **	M	Issue No.	70
LM End	9.94	Issue Type +	Ma	Location *	LS
Category	Earthen Levee			GPS Latitude/Longitude	
				Start	End
Item	Trim / Thin Trees			39.293633 °	39.293633 °
				-121.606986 °	-121.606986 °
DWR ID	DWR_RD0010_02_s_2016_70				
Comment Code					
T1 : Trim trees to at least five feet above ground level.					
Inspector Comment					
Trim tree up five feet for visibility and access.

View of tree on landside toe that need to be trimmed up five feet for visibility and access.

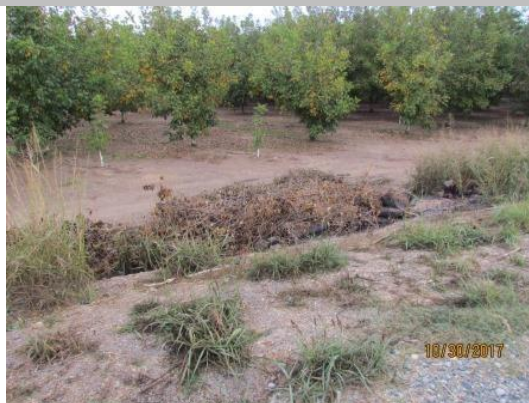
Photo 1 of 1 : SP_2018_RD0010_164_60_20180302_00030.jpg

LM Start	9.96	Rating **	M	Issue No.	60
LM End	9.96	Issue Type +	En	Location *	LS
Category	Earthen Levee			GPS Latitude/Longitude	
				Start	End
Item	Encroachments			39.293770 °	39.293770 °
				-121.607244 °	-121.607244 °
DWR ID	DWR_RD0010_02_f_2016_60				
Comment Code					
PR : Prunings					
Inspector Comment					
Remove pruning's from levee toe.

View of large pile of pruning's on the landside toe looking downstream, Fall 2017.

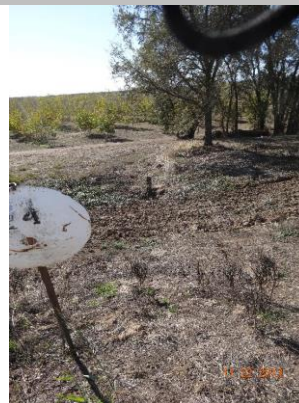
Photo 2 of 3 : UCIP_SP_2018_24838_44741.jpg

Comment Code						
Inspector Comment						
FS_ID:24838 DS_ID:21303 EP_NO: 1069 Repair Type: Non-Urgent Crossing Status: Found UCIP Comments: Unable to find the crossing on landward side-- indicators found of crossing. Need to coordinate with owner to determine status of crossing. If crossing is no longer in use owner will need to contact the CVFPB to comply with Title 23. This crossing is referenced in the USACE Periodic Inspection as item USACE_CESPK_HON2_2013_p_0442. FIELD_STRUCT_DESC: 24-inch steel gravity irrigation pipe through the levee, 13 feet below the crown. Concrete cutoff wall around the pipe at each shoulder. Flap gate and concrete headwall on the waterside (WS) end. Slide gate, concrete saddle, and apron on the landside (LS) end. (Plans for installation of a 24-inch corrugated iron pipe through the levee authorized under Permit No. 1069, 1946 - Pacific Ranch, care of Chas. J. Mathews). [Additional Reference(s): DWR Levee Log, 2005. USACE Sacramento O&M Manual 151, May 1953, (Station 638+00)]. FS Date: 4/30/2013

View of waterward side.

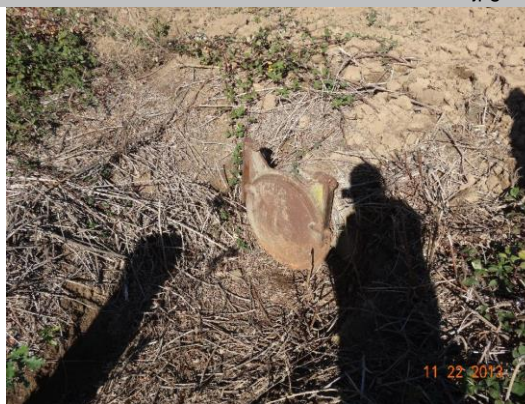
Photo 3 of 3 : UCIP_SP_2018_24838_44740.jpg

View of flap gate located on waterward side.

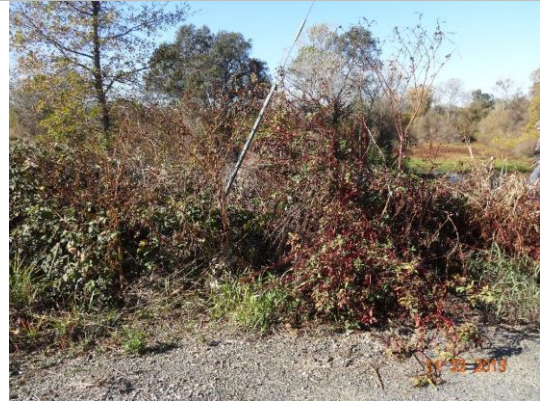
Photo 1 of 3 : UCIP_SP_2018_24839_44745.jpg

Comment Code					
Inspector Comment					
FS_ID:24839 DS_ID:21304 EP_NO: N/A Repair Type: Non-Urgent Crossing Status: Found UCIP Comments: Rip rap was used to stabilize the waterward slope during high water as a means of emergency repair--unable to determine storm event when repair was performed. Recommend obtaining records of the repair and to determine if crossing is still being used. Need to determine owner. Dense vegetation limits the inspector's visibility to identify signs of pipe failure (leaks) along the slope. Recommend removing vegetation along pipe alignment to conduct proper inspection of structure and appurtenances. This crossing is referenced in the USACE Periodic Inspection as item USACE_CESPK_HON2_2013_p_0458 and 460. FIELD_STRUCT_DESC: 24-inch steel irrigation discharge pipe through the levee, 5 feet below the crown. Slide gate in a 36-inch concrete riser on the landside (LS) shoulder. Gate valve in a pump house on the waterside (WS) slope. Concrete headwall, saddle, and apron on the WS end. [Additional Reference(s): DWR Levee Log, 2005. USACE Sacramento O&M Manual 151, May 1953, (Station 655+65)]. FS Date: 4/30/2013

View of waterward shoulder behind vegetation is standpipe.

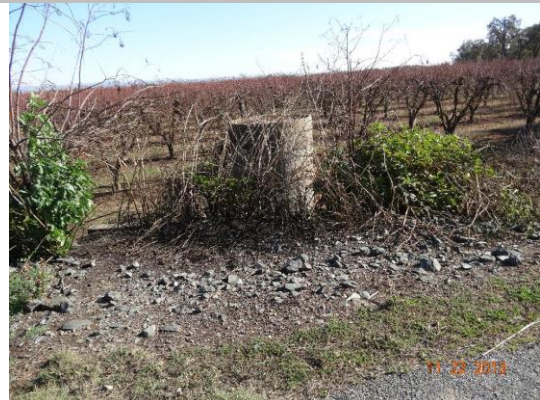
Photo 2 of 3 : UCIP_SP_2018_24839_44742.jpg

View of standpipe located on landward side.

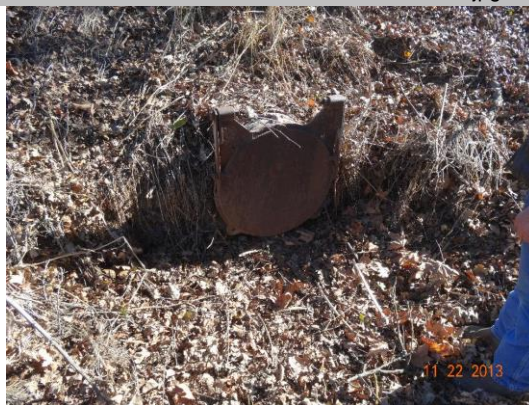
Photo 2 of 3 : UCIP_SP_2018_24840_44752.jpg

View of flap gate located on waterward side.

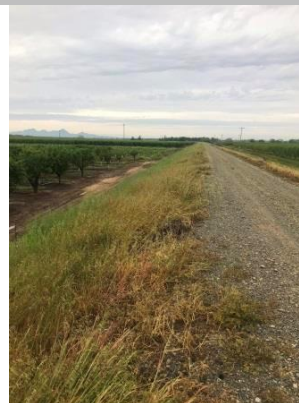
Photo 1 of 1 : SP_2018_RD0010_165_4_20180411_00016.jpg

LM Start	0.00	Rating **	A	Issue No.	4
LM End	2.79	Issue Type +	Ma	Location *	LS
Category	Earthen Levee			GPS Latitude/Longitude	
				Start	End
Item	Vegetation			39.310043 °	39.298575 °
				-121.616328 °	-121.570035 °
DWR ID	DWR_RD0010_03_f_2017_4				
Comment Code					
V1 : Control annual grass and weeds on the levee slopes and easements.					
Inspector Comment					
Annual vegetation is maintained, Spring 2018.

View looking downstream landside where the annual vegetation is maintained, Spring 2018.

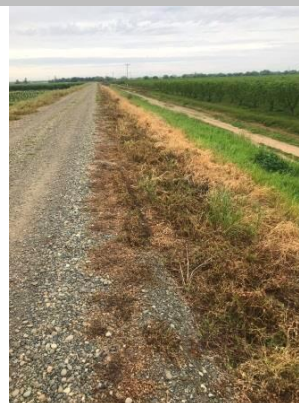
Photo 1 of 1 : SP_2018_RD0010_165_5_20180411_00015.jpg

LM Start	0.00	Rating **	A	Issue No.	5
LM End	2.79	Issue Type +	Ma	Location *	WS
Category	Earthen Levee			GPS Latitude/Longitude	
				Start	End
Item	Vegetation			39.310043 °	39.298575 °
				-121.616328 °	-121.570035 °
DWR ID	DWR_RD0010_03_f_2017_5				
Comment Code					
V1 : Control annual grass and weeds on the levee slopes and easements.					
Inspector Comment					
Annual vegetation is maintained, Spring 2018.

View looking downstream waterside where the annual vegetation is maintained, Spring 2018.

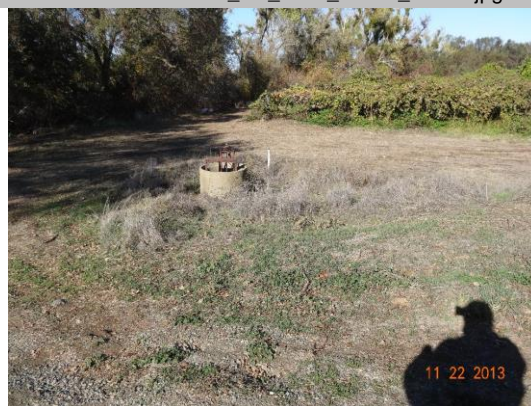
Photo 1 of 3 : UCIP_SP_2018_24841_44759.jpg

LM Start	0.01	Rating **	M	Issue No.	12	
LM End	0.01	Issue Type +	En	Location *		
Category	Supplemental			GPS Latitude/Longitude		
				Start	End	
Item	DWR UCIP Field Study			39.310096 °	39.310096 °	
				-121.616250 °	-121.616250 °	
DWR ID						
Comment Code						
Inspector Comment						
FS_ID:24841						
DS_ID:21306						
EP_NO: N/A						
Repair Type: Non-Urgent						
Crossing Status: Found						
UCIP Comments: Debris found inside crossing--recommend removing it.						
FIELD_STRUCT_DESC: 24-inch corrugated metal gravity drainage pipe						
through the levee, 6 feet below the crown. Slide gate in a concrete						
standpipe on the waterside (WS) end. [Additional Reference(s): DWR						
Levee Log, 2005].						
FS Date: 5/1/2013

View of waterward side.

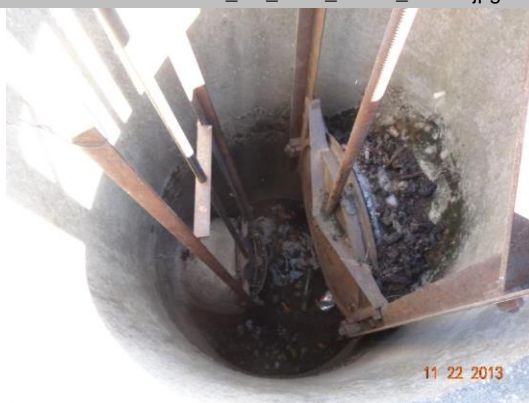
Photo 3 of 3 : UCIP_SP_2018_24841_44758.jpg

LM Start	0.01	Rating **	M	Issue No.	12 (cont)	
LM End	0.01	Issue Type +	En	Location *		
Category	Supplemental			GPS Latitude/Longitude		
				Start	End	
Item	DWR UCIP Field Study			39.310096 °	39.310096 °	
				-121.616250 °	-121.616250 °	
DWR ID						
Comment Code						
Inspector Comment						
FS_ID:24841 DS_ID:21306 EP_NO: N/A Repair Type: Non-Urgent Crossing Status: Found UCIP Comments: Debris found inside crossing--recommending removing it. FIELD_STRUCT_DESC: 24-inch corrugated metal gravity drainage pipe through the levee, 6 feet below the crown. Slide gate in a concrete standpipe on the waterside (WS) end. [Additional Reference(s): DWR Levee Log, 2005]. FS Date: 5/1/2013

Inside view of concrete standpipe with 2 screw gates inside.

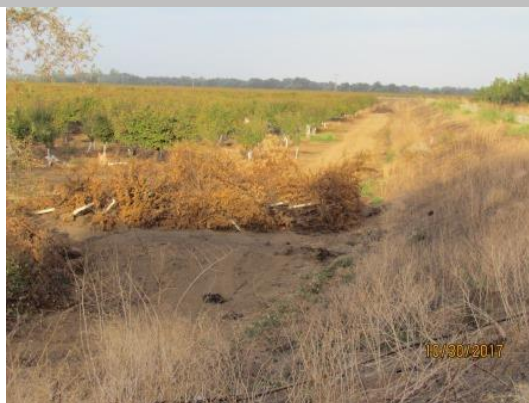
Photo 1 of 1 : SP_2018_RD0010_165_7_20180302_00004.jpg

LM Start	0.62	Rating **	M	Issue No.	7
LM End	0.62	Issue Type +	En	Location *	LS
Category	Earthen Levee			GPS Latitude/Longitude	
				Start	End
Item	Encroachments			39.310069 °	39.310069 °
				-121.604883 °	-121.604883 °
DWR ID	DWR_RD0010_03_s_2016_7				
Comment Code					
PR : Prunings					
Inspector Comment					
Remove pruning's from levee toe.

View of pruning's at landside levee toe looking downstream, Fall 2017.

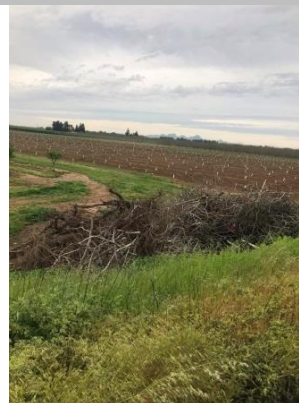
Photo 1 of 1 : SP_2018_RD0010_165_11_20180411_00017.jpg

LM Start	0.77	Rating **	M	Issue No.	11
LM End	0.77	Issue Type +	En	Location *	LS
Category	Earthen Levee			GPS Latitude/Longitude	
				Start	End
Item	Encroachments			39.309160 °	39.309160 °
				-121.602368 °	-121.602368 °
DWR ID	DWR_RD0010_03_s_2018_11				
Comment Code					
PR : Prunings					
Inspector Comment					
Pruning's need to be removed from levee toe, Spring 2018.

View looking downstream landside of pruning's that need to be removed from levee toe, Spring 2018.

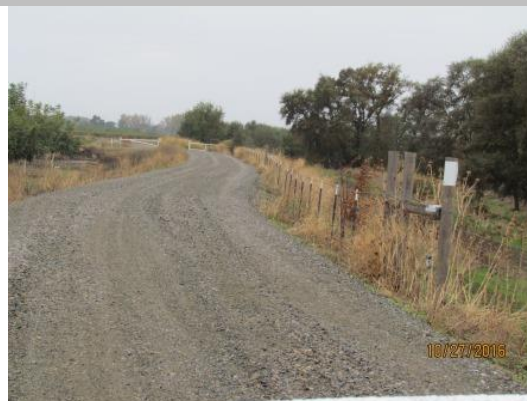
Photo 1 of 1 : SP_2018_RD0010_165_8_20180302_00005.jpg

LM Start	1.08	Rating **	M	Issue No.	8
LM End	1.21	Issue Type +	En	Location *	WS
Category	Earthen Levee			GPS Latitude/Longitude	
				Start	End
Item	Encroachments			39.307106 °	39.306422 °
				-121.597439 °	-121.595205 °
DWR ID	DWR_RD0010_03_s_2016_8				
Comment Code					
FE : Fence					
Inspector Comment					
Unpermitted fence on waterside levee hinge point.

View of an unpermitted fence on waterside levee hinge point.

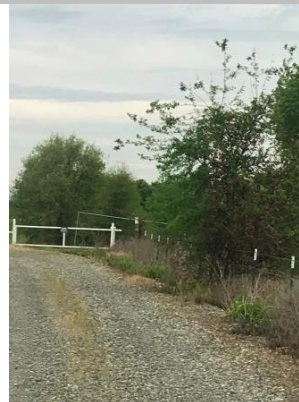
Photo 1 of 1 : SP_2018_RD0010_165_10_20180411_00018.jpg

LM Start	1.10	Rating **	M	Issue No.	10
LM End	1.10	Issue Type +	Ma	Location *	WS
Category	Earthen Levee			GPS Latitude/Longitude	
				Start	End
Item	Trim / Thin Trees			39.306995 °	39.306995 °
				-121.597116 °	-121.597116 °
DWR ID	DWR_RD0010_03_s_2018_10				
Comment Code					
T2 : Thin trees to allow visibility of the ground and room to flood fight.					
Inspector Comment					
Tree needs to be trimmed for access and visibility, Spring 2018.

View looking downstream waterside of a tree that needs to be trimmed for access and visibility, Spring 2018.

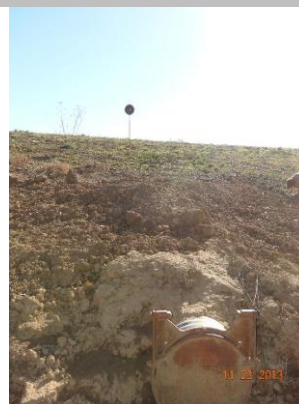
Photo 2 of 3 : UCIP_SP_2018_24842_44762.jpg

View of waterward slope.

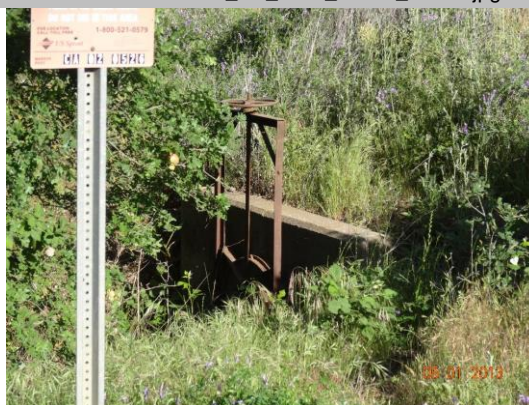
Photo 1 of 2 : UCIP_SP_2018_24883_44820.jpg

Comment Code					
Inspector Comment					
FS_ID:24883 DS_ID:21308 EP_NO: N/A Repair Type: Non-Urgent Crossing Status: Found UCIP Comments: Dense vegetation limits the inspector's visibility to identify signs of pipe failure (leaks) along the slope. Recommend removing vegetation along pipe alignment to conduct proper inspection of structure and appurtenances. FIELD_STRUCT_DESC: 24-inch corrugated metal gravity drainage pipe through the levee, 12 feet below the crown. Corrugated metal cutoff wall around the pipe at each shoulder. Flap gate on the waterside (WS) end. Slide gate on the landside (LS) end. Concrete headwall at the LS toe. [Additional Reference(s): DWR Levee Log, 2005. USACE Sacramento O&M Manual 151, May 1953, (Station 192+33)]. FS Date: 5/1/2013

View of slide gate and concrete headwall located on landward side.

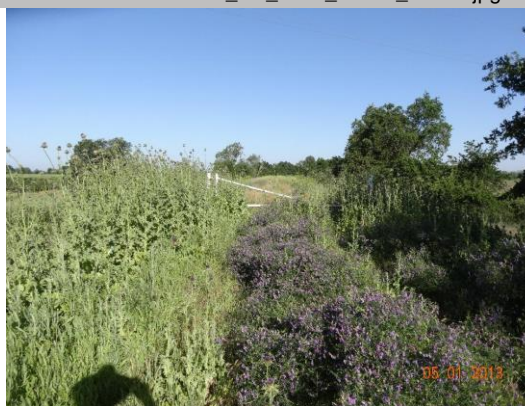
Photo 2 of 2 : UCIP_SP_2018_24883_44821.jpg

Comment Code						
Inspector Comment						
FS_ID:24883						
DS_ID:21308						
EP_NO: N/A						
Repair Type: Non-Urgent						
Crossing Status: Found						
UCIP Comments: Dense vegetation limits the inspector's visibility to identify signs of pipe failure (leaks) along the slope. Recommend removing vegetation along pipe alignment to conduct proper inspection of structure and appurtances.						
FIELD_STRUCT_DESC: 24-inch corrugated metal gravity drainage pipe through the levee, 12 feet below the crown. Corrugated metal cutoff wall around the pipe at each shoulder. Flap gate on the waterside (WS) end. Slide gate on the landside (LS) end. Concrete headwall at the LS toe. [Additional Reference(s): DWR Levee Log, 2005. USACE Sacramento O&M Manual 151, May 1953, (Station 192+33)].						
FS Date: 5/1/2013

View of levee crown--dense vegetation.
